INDOOR AIR QUALITY ASSESSMENT

**Abraham Lincoln Elementary School
300 Chelmsford Street
Lowell, Massachusetts**

Prepared by:
Massachusetts Department of Public Health
Bureau of Environmental Health Assessment
June, 2000

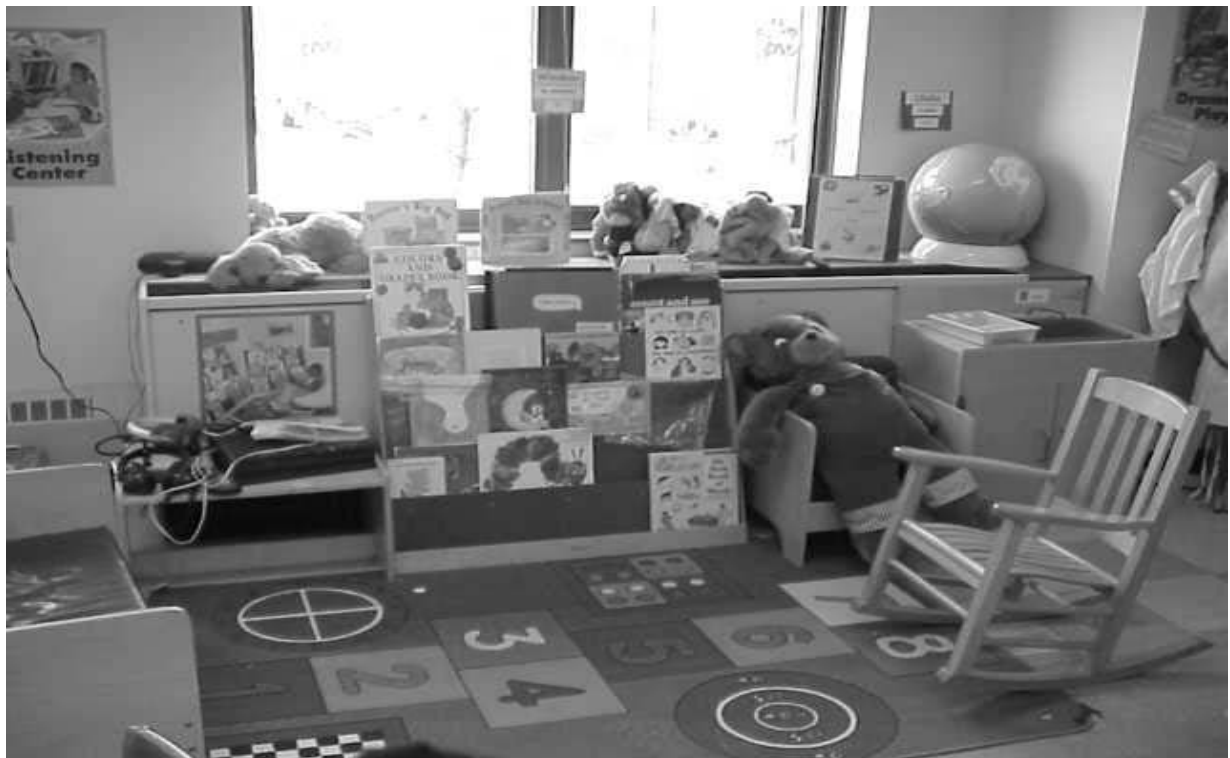
Picture 1

Obstructions to airflow, such as books, papers and posters on top of univents, and bookcases, tables and desks in front of univent returns, were seen in a number of classrooms (see Picture 1). To function as designed, univents and univent returns must remain free of obstructions. Importantly, these units must be activated and allowed to operate during school hours. Also noted in the interior of some univents were learning materials (i.e., flashcards), trash and debris (see Picture 2).

Objects Stored on and around Classroom Univent Obstructing Airflow

3. Change filters for air-handling equipment as per the manufacture's instructions or more frequently if needed.
4. Remove all blockages from univents and exhaust ventilators to ensure adequate airflow. Clean out interiors of univents.

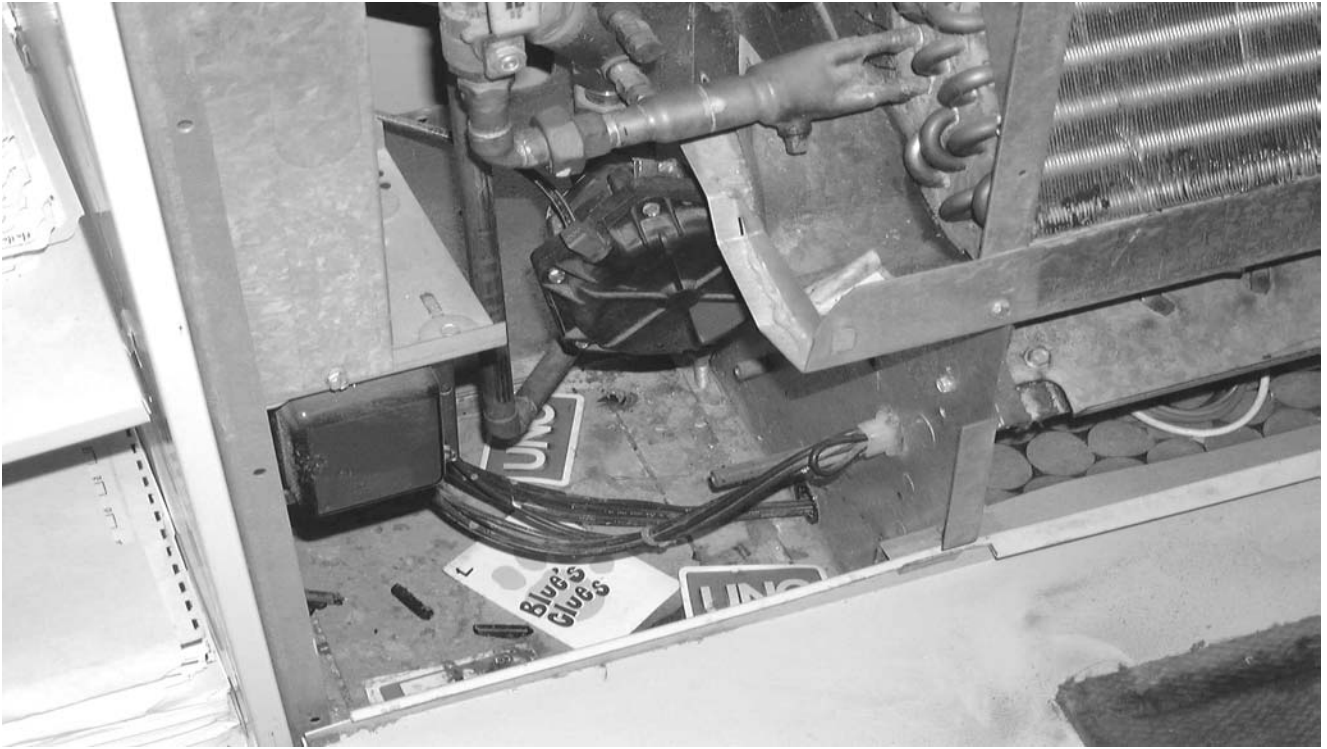
Picture 2

Interior of Classroom Univent Note Materials and Debris on Floor

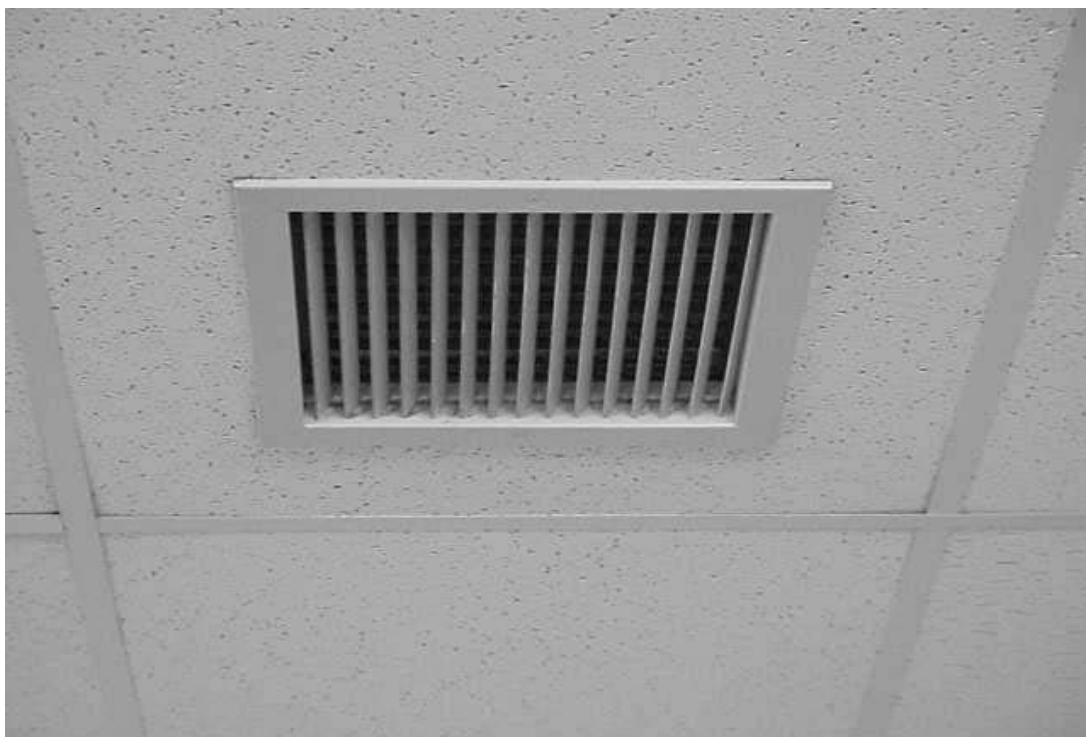
Picture 3

The mechanical exhaust ventilation system consists of ceiling mounted exhaust vents (see Picture 3). Exhaust vents were not functioning in a number of classrooms,

which can indicate that exhaust ventilation was turned off, or that rooftop motors were not functioning. BEHA staff examined exhaust motors on the roof and found that many exhaust motors were off. In addition, exhaust ventilation for the cafeteria and computer room was also deactivated during the assessment.

Ceiling-Mounted Exhaust Vent Noted in Classroom

1. To maximize air exchange, the BEHA recommends that both supply and exhaust ventilation operate continuously during periods of school occupancy independent of classroom thermostat control.

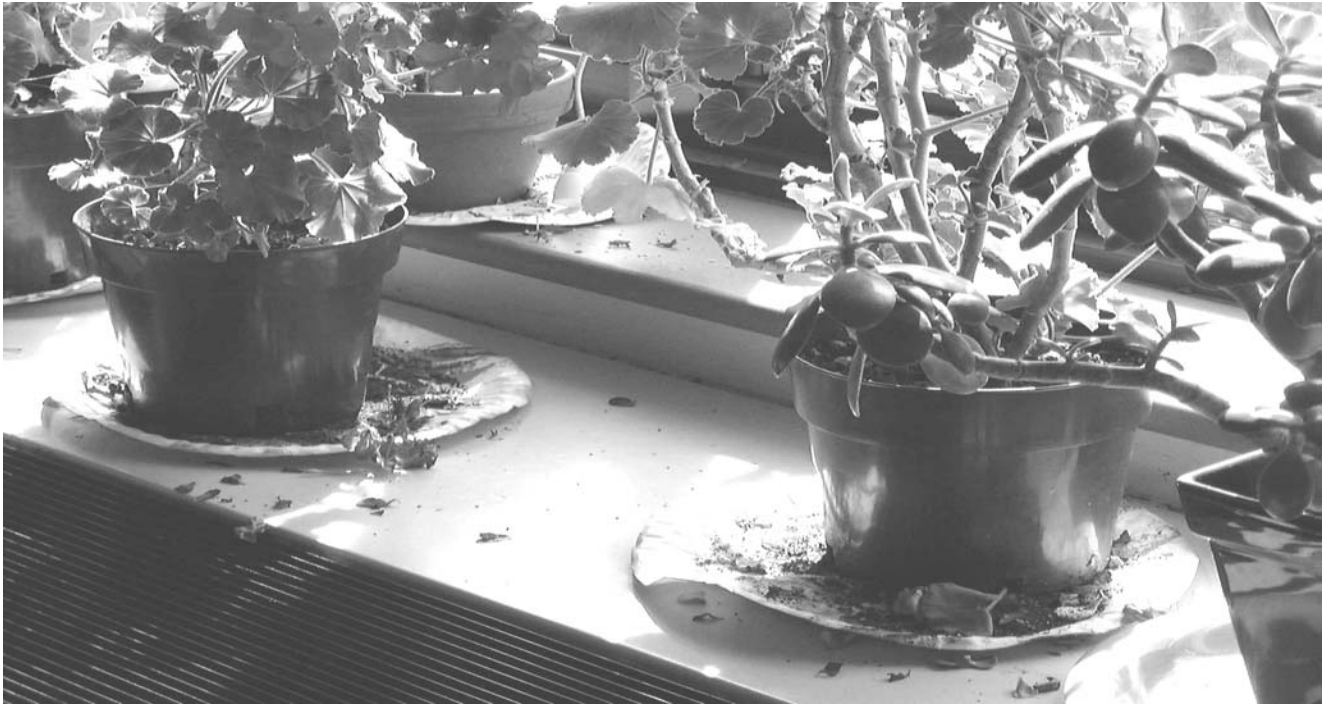
Picture 4

Several classrooms had a number of plants. Moistened plant soil and drip pans can be a source of mold growth. The lack of drip pans can lead to water pooling and mold growth on windowsills. Plants are also a source of pollen. Plants in several classrooms were noted near univent air diffusers (see Picture 4). Plants should be located away from the air stream of ventilation sources to prevent the aerosolization of mold, pollen or particulate matter throughout the classroom.

**Flowering Plants Noted on Top of Classroom Univent
Note Soil and Plant Debris on Surface**

8. Keep plants away from univents in classrooms. Ensure plants have drip pans, examine drip pans for mold growth and disinfect areas with an appropriate antimicrobial where necessary.

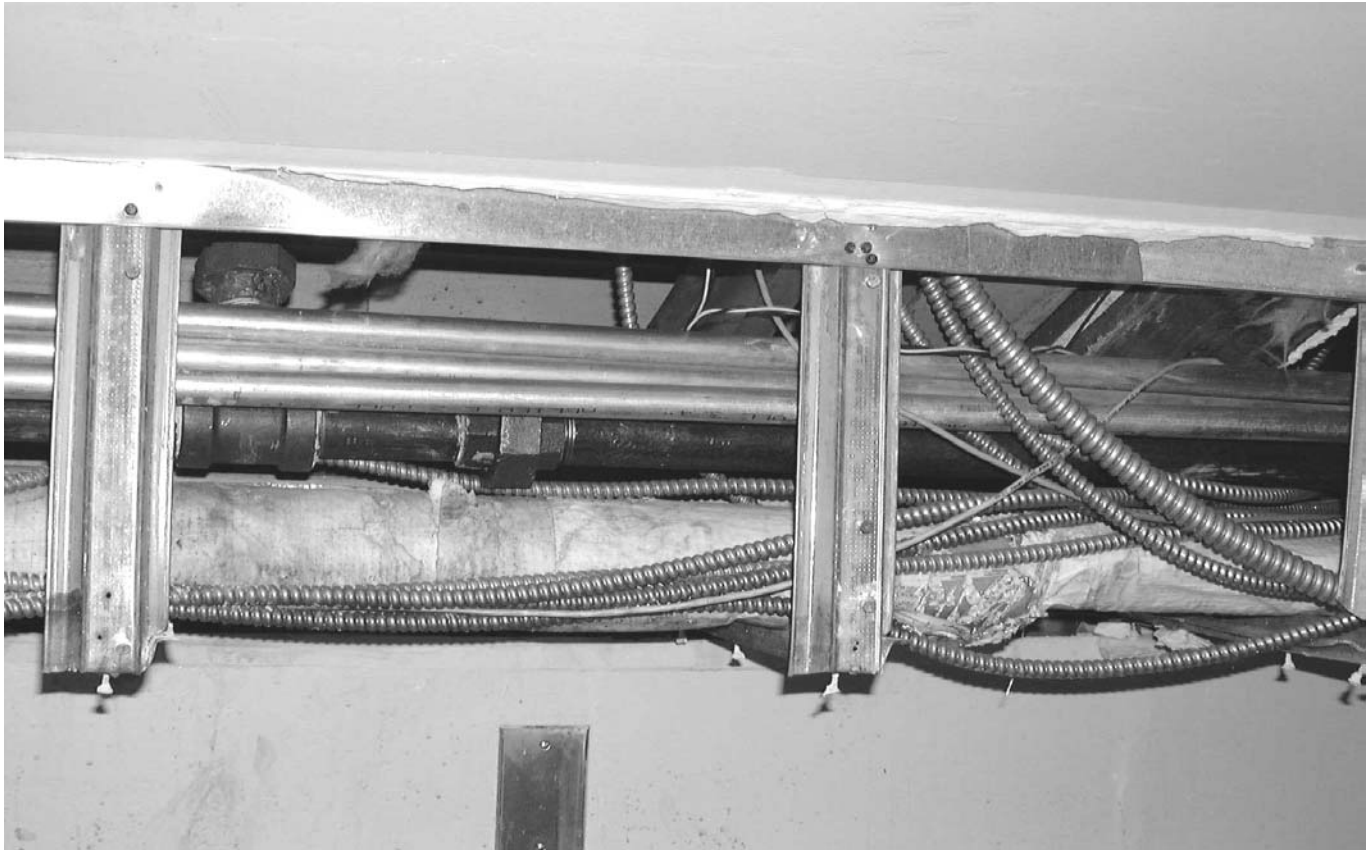
Picture 5

Water damaged pipe insulation and ceiling tiles were noted in the northwest stairwell, which can indicate leaks from either the roof or plumbing system (see Picture 5). If wetted repeatedly, porous materials (i.e., ceiling tiles, pipe insulation) can grow mold and be a source of unpleasant odors. Water-damaged building materials should be replaced after a water leak is discovered and repaired. A recent leak above the ceiling tiles was reported in Mr. Hall's Office adjacent to the library; a water-stained ceiling tile was noted in this area (see Picture 6).

Water-Damaged Pipe Insulation in Northwest Hallway

9. Replace any remaining water-stained ceiling tiles, wall board and pipe insulation. Examine the areas above and around these areas for mold growth. Repair water leaks and disinfect areas of water leakage with an appropriate antimicrobial if necessary.

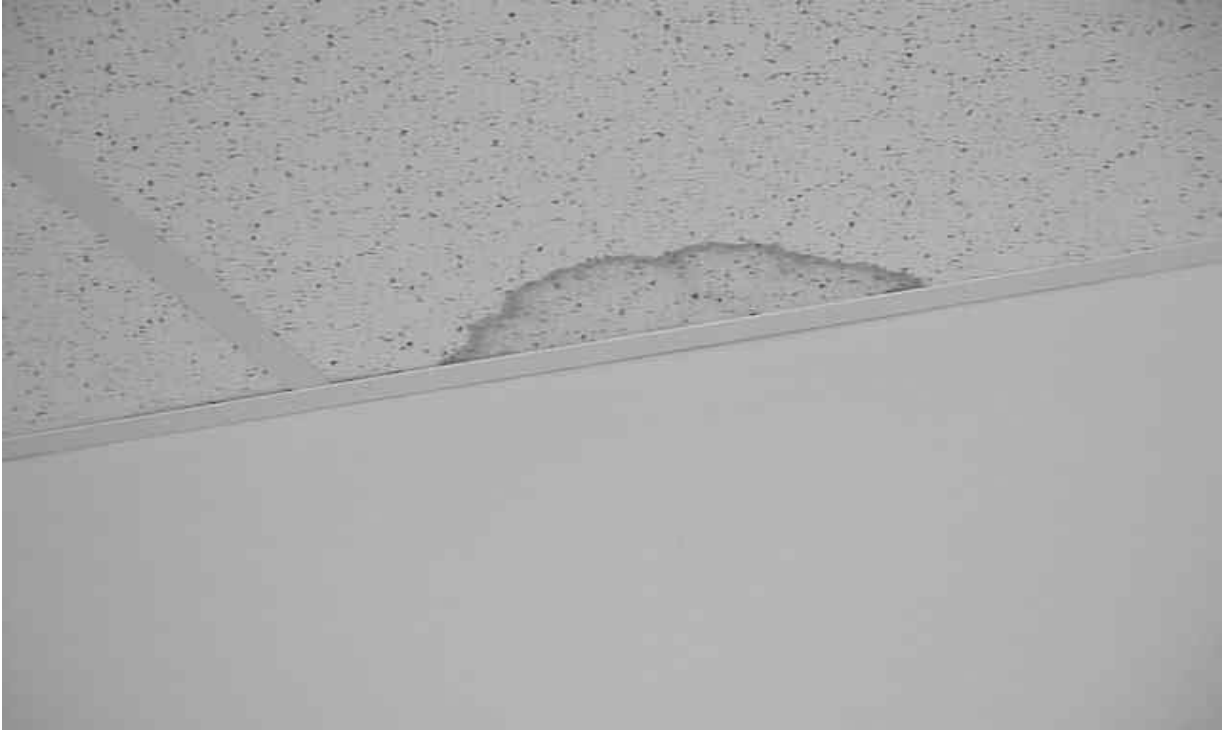
Picture 6

Water-Stained Ceiling Tile Noted in Office Adjacent to the Library

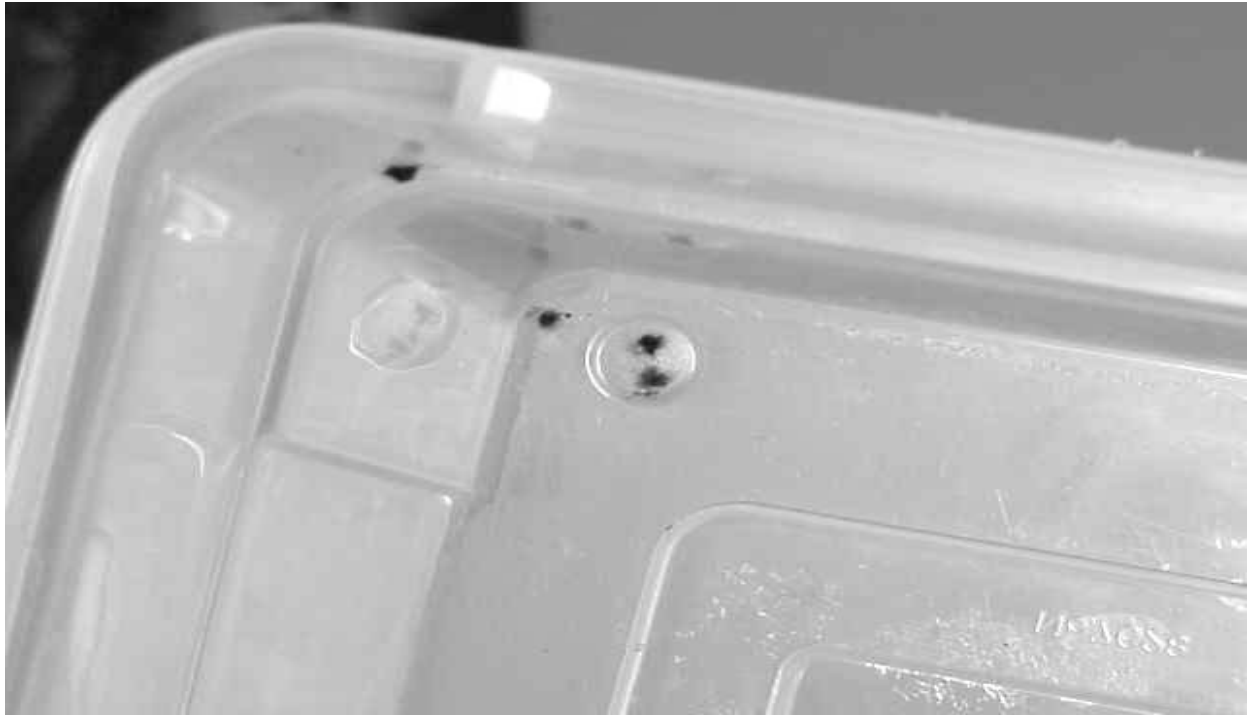
Picture 7

Building occupants reported mold/mildew growth on plastic items in room 106 (see Picture 7). A black mold-like substance was noted on these items. Non-porous items should be cleaned with an appropriate antimicrobial. Porous items should be discarded because they are difficult to clean. Also noted in this room were spaces between the sink countertop and backsplash (see Picture 8). Improper drainage or overflow could lead to water penetration of countertop wood, the cabinet interior and behind cabinets. Reports of mold growth on water-damaged wallboard were also expressed to BEHA staff. Like other porous materials, if gypsum wallboard becomes wet repeatedly it can provide a medium for mold growth, which is difficult to clean. This material can be irritating to sensitive individuals. Water-damaged gypsum wallboard

Plastic Container Noted in Room 106 with Possible Mold Colonies (as Indicated by Black Spots)

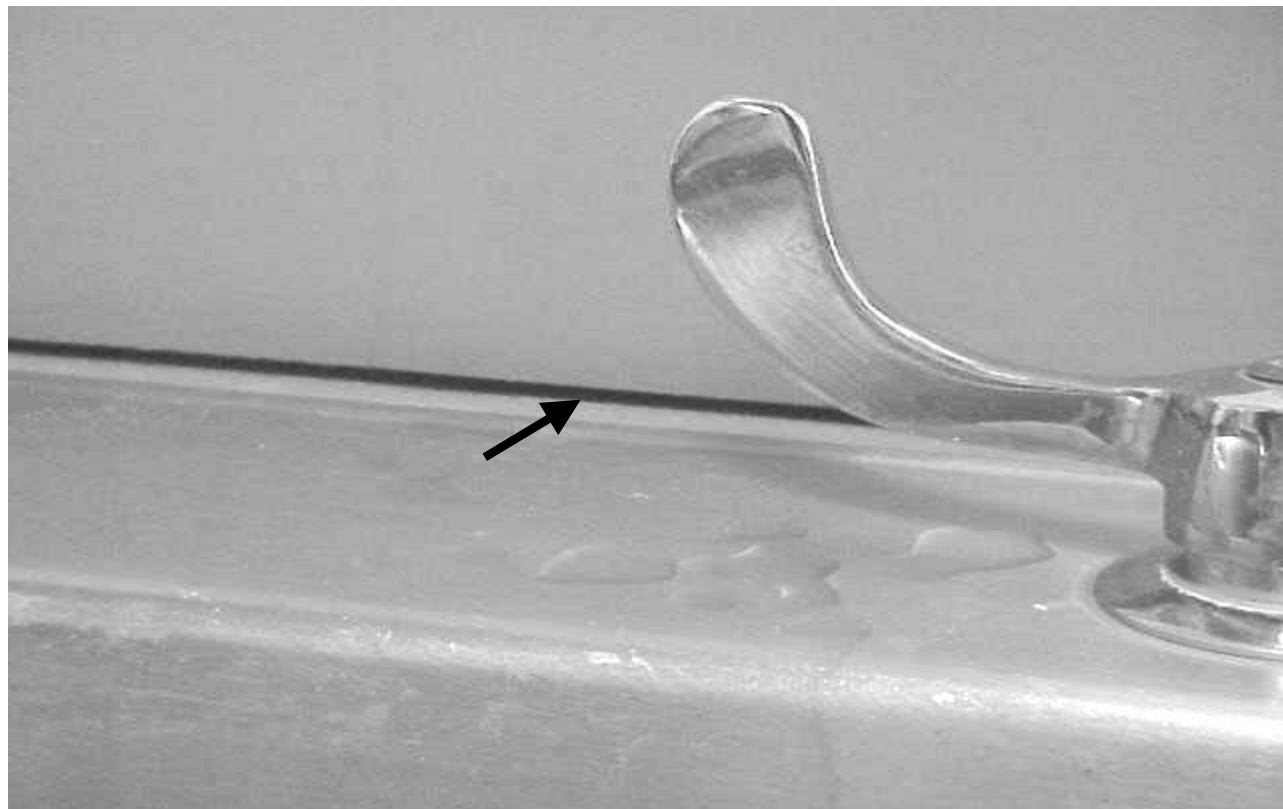
Picture 8

Space Noted Between Backsplash and Countertop in Room 106

11. Seal areas around sink in classroom 106, to prevent water-damage to interior of cabinets and adjacent wallboard. Inspect wallboard for water-damage and mold/mildew growth, repair/replace as necessary. Disinfect areas of microbial growth with an appropriate antimicrobial as needed.

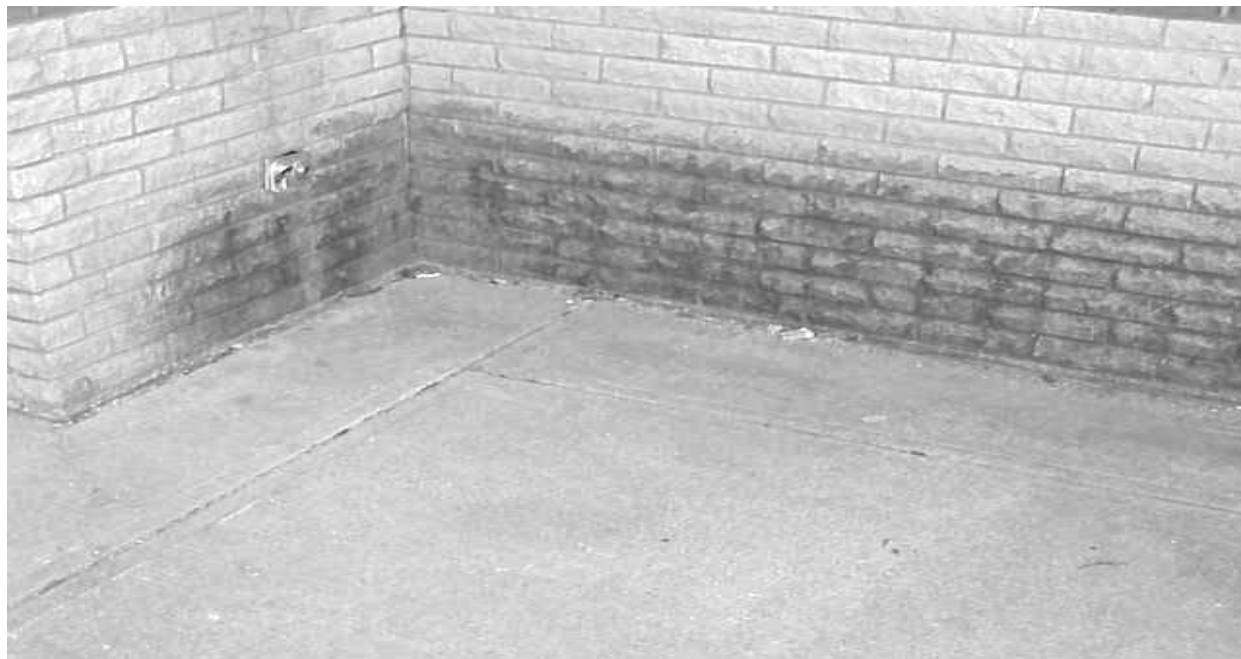
A perimeter inspection of the building was conducted in which BEHA staff noted a potential problem with the school's drainage system. Picture 9 shows a green organic material growing on exterior brickwork near the main entrance of the building. The pattern and location of growth appears to be evidence of improper drainage, which would allow back-splashing rainwater to impact on the ground below and chronically wet the exterior wall. Downspouts should be designed to direct rainwater away from the base of the building to prevent the chronic wetting of exterior walls which can result in damaged brickwork and/or mold growth. Over time rainwater can work its way into mortar and brickwork causing cracks and fissures, which can lead to water penetration.

Green Organic Material Noted on Exterior Brickwork

10. Inspect/install drainage to prevent the impact of back-splashing rainwater on exterior brickwork. Remove growth and disinfect areas noted in Picture 9 with an appropriate antimicrobial as needed.

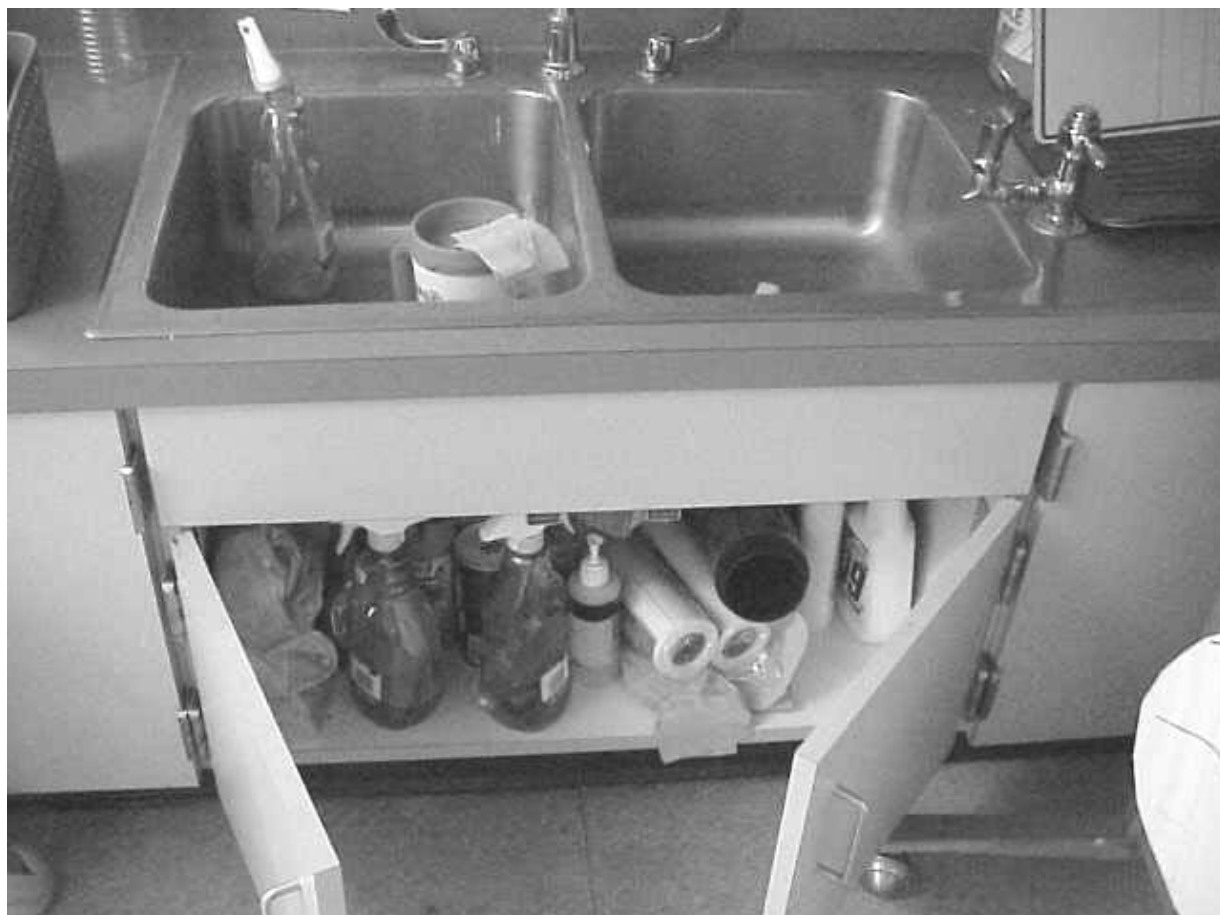
Picture 10

Several other conditions were noted during the assessment, which can affect indoor air quality. Cleaning products and other materials (e.g., spray paint, rubber cement and isopropyl alcohol) were found on counter-tops and beneath sinks in a number of classrooms (see Picture 10). These items can contain chemicals, which can be irritating to the eyes, nose and throat and should be stored properly and out of reach of students. In addition, rubber cement is a flammable material, which should be stored in a flameproof cabinet.

Cleaning Products Stored beneath Sink in Unlocked Classroom Cabinet

13. Store cleaning products and chemicals properly and keep out of reach of students.
14. Relocate or consider reducing the amount of materials stored in classrooms to allow for more thorough cleaning of classrooms. Clean items regularly with a wet cloth or sponge to prevent excessive dust build-up.

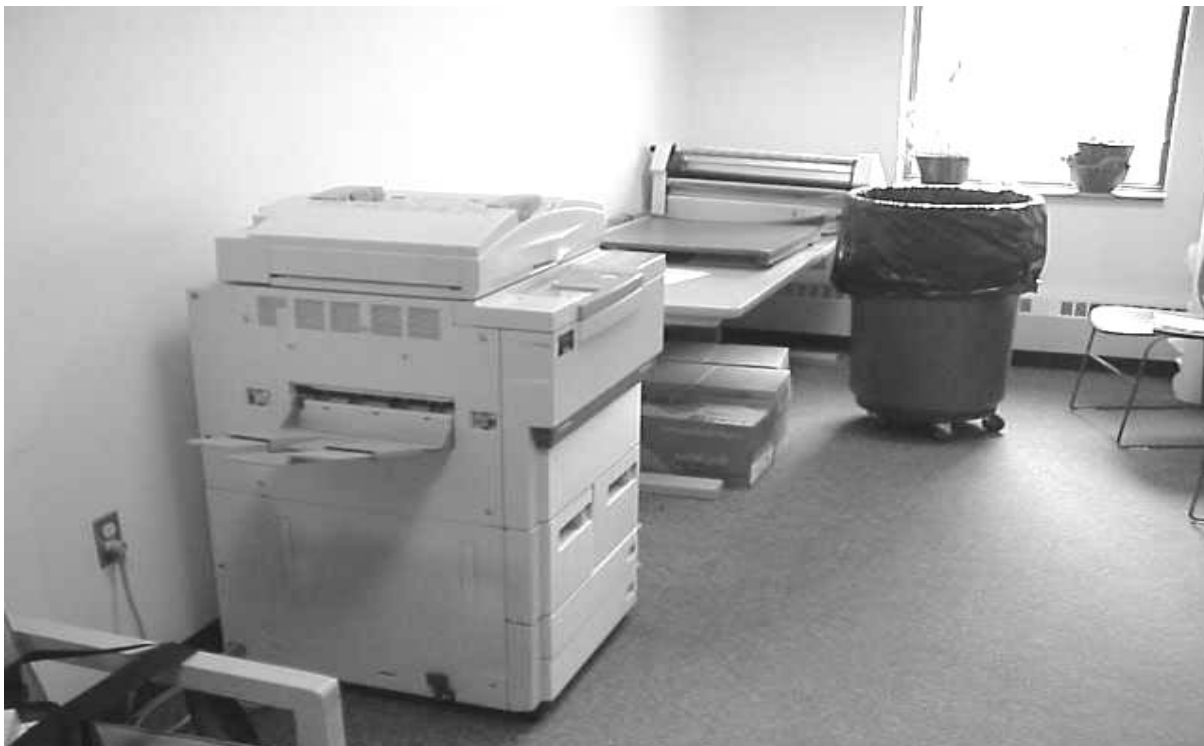
Picture 11

Several areas have lamination machines and/or photocopiers. Lamination machines give off odors (see Picture 11). Volatile organic compounds (VOCs) and ozone can be produced by photocopiers, particularly if the equipment is older and in frequent use. Ozone is a respiratory irritant (Schmidt Etkin, D., 1992). School personnel should ensure that local exhaust ventilation is activated while equipment is in use to help reduce excess heat and odors in these areas.

Photocopiers and Lamination Machine Noted in Teacher's Workroom

15. Ensure exhaust ventilation is functioning in areas that contain lamination machines and photocopiers.
16. Consider using charcoal filters in univents of classrooms that have a history of wood stove odors from neighboring houses during the heating season.

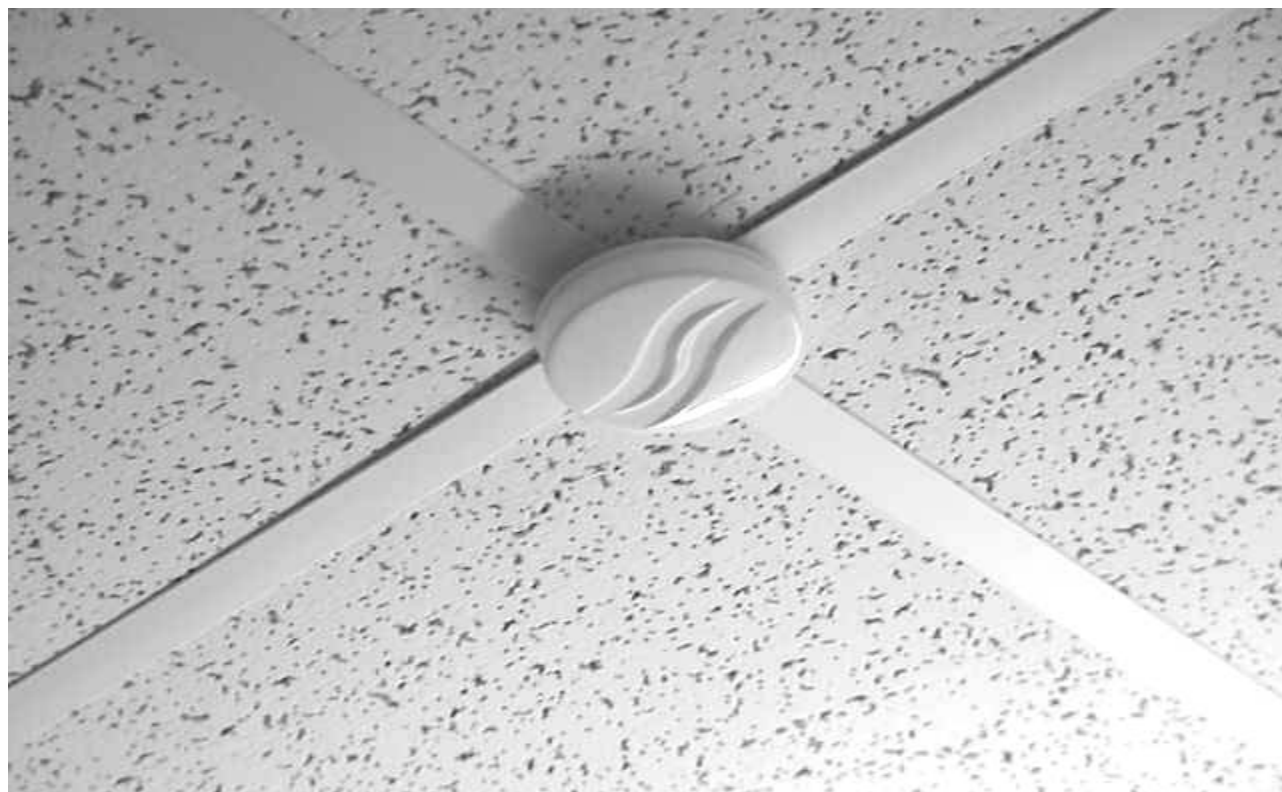
Picture 12

A strong odor of deodorizer was detected upon entry into the boy's and girl's first floor restrooms. The source was identified as ceiling-mounted, time-released air fresheners (see Picture 12). Air fresheners and cleaning products contain chemicals that can be irritating to certain sensitive individuals. In addition, air fresheners do not remove materials causing odors, but rather mask odors which may be present in the area.

Ceiling-Mounted Time-Released Air Freshener Noted in Restroom

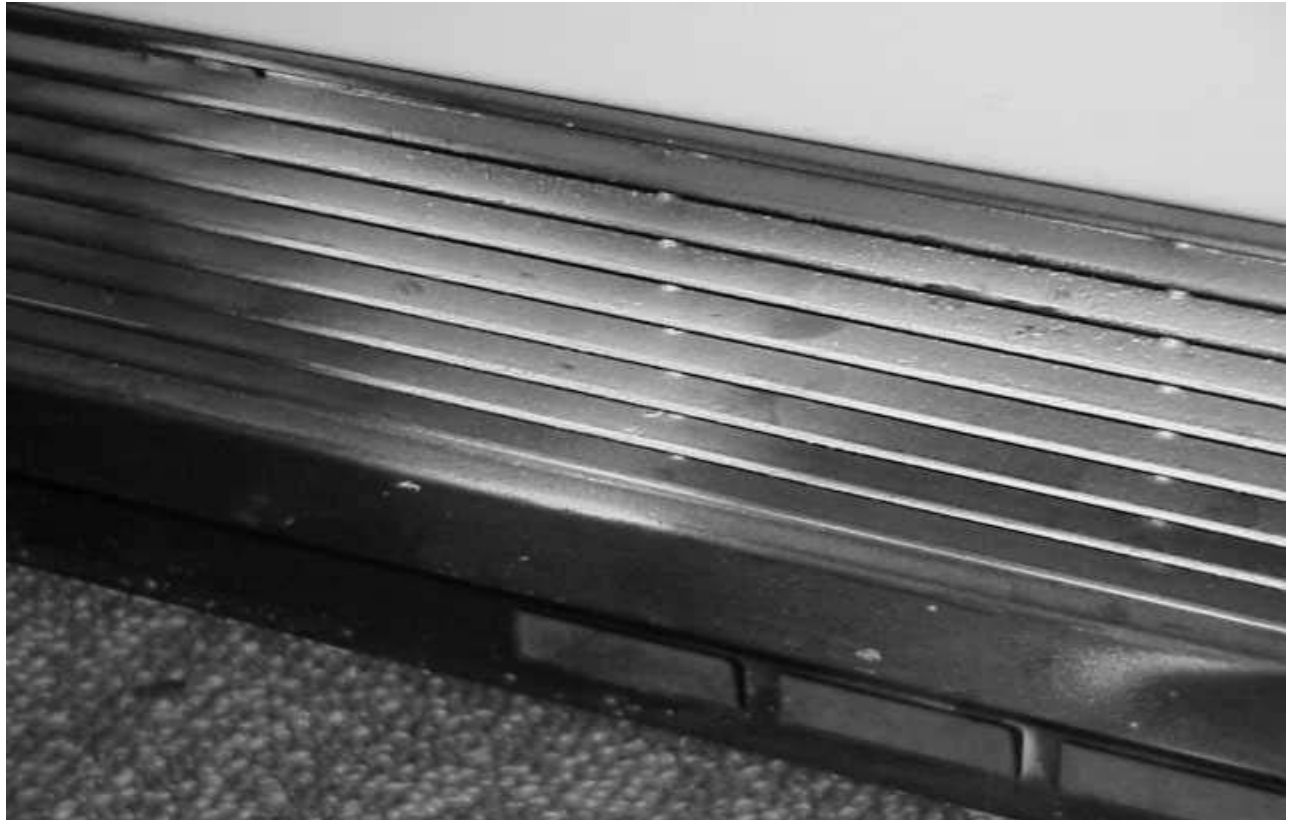
Picture 13

An unidentified white powdery material was noted on the return grill of the univent in room 215 (AV room) (see Picture 13). This material should be identified and cleaned to avoid being drawn in to the univent air stream and distributed throughout the room.

**Unidentified White Powdery Substance Noted on Univent Return Grill
in the AV Room (Room 215)**
